Short circuit indicator for HV cables in MV substations

by Dr. Vladimir Gurevich, Israel Electric Corporation

The article describes a simple electronic fault passage indicator that reacts to damage of HV cable connecting the transformer with the feeder bus bar on medium voltage substations

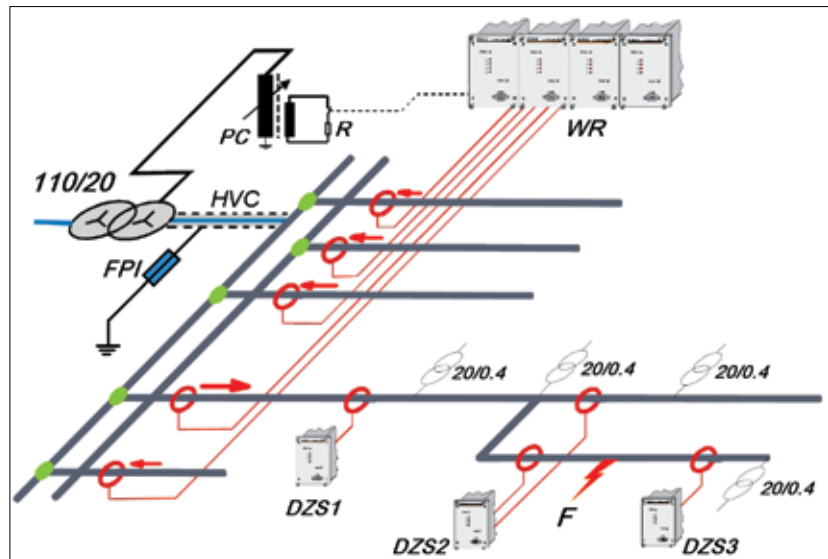
Fig. 1: The block diagram of system for detecting of single-phase short circuits on the basis of Petersen's coil and the directional zero sequence relays: PC - Petersen's coil; R - the powerful resistor 2,5 Ω ; WR - wattmetric relays; DZS - directional active zero-sequence current relays; HVC - high-voltage cable which has been not covered by detecting system; FPI - fault passage indicator; F - a place of the short circuit.

Nevertheless, it is difficult to reliably identify a faulted feeder in a ramified distribution network. The simplest way to accomplish this, is by serially switching-off (or, alternatively, serially switching-on) each feeder (sometimes this is carried out by an automatic system) until the signal indicating the damage does not disappear (or, alternatively, does not appear). The most popular means for identifying a faulted feeder is the Petersen coil used in conjunction with a directional zero-sequence active power relay (also called "watt-metric relays, or WR) [Fig. 1].

By and large, the Petersen coil (PC) in this system is not a coil at all but a transformer with several windings. One of the windings is connected between the system neutral and the ground and it has an inductance close to the capacitance of the network. Whenever a single-phase short circuit occurs, a small current develops through the PC and a low voltage appears across one of the PC auxiliary windings. This voltage is detected by a voltage relay that connects a low resistance high-power resistor R to one of the PC windings.

Thus, the short circuit current contains an appreciable active component which is registered by the watt-metric relay. Due to directional property of the watt-metric relay, only the relay installed in the faulted feeder operates. The remaining relays are not activated due to reversed direction of the power flow at their point of installation. In order to maintain appropriate selectivity, the system can be equipped with additional directional active zero-sequence current

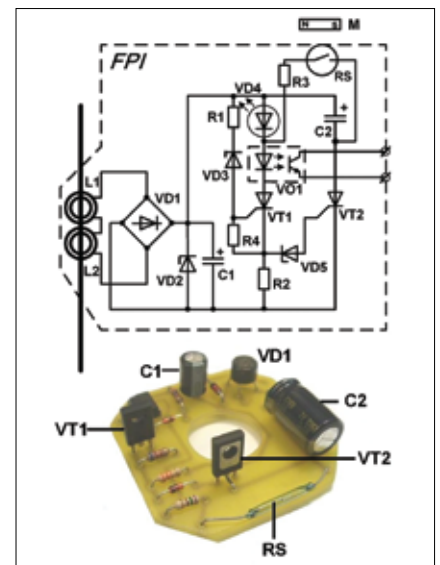
Fig. 2: Circuit diagram and PCB of the fault passage indicator (FPI).

The author developed a simple electronic fault passage indicator (FPI) that reacts to such damage, (Fig. 2). A feature of the indicator is the absence of an external power supply on the one hand, and a low power input signal on the other. These features complicate the design of the indicator's circuit.

The indicator contains two parallel nonlinear circuits that change their state during operation. The first circuit contains a light-emitting diode VD4, an optocoupler VO1 and a thyristor VT1. The second circuit contains a capacitor C2 and a thyristor VT2. In addition, there are two series connected zener diodes VD3 and VD5, that are used as threshold elements, connected in series with the gates of the thyristors VT1 and VT2. The values of resistors R2 and R4 are relatively

high (33 k Ω and 6,2 k Ω , respectively) and have no influence on the current through the zener diodes. The device picks-up when the voltage levels on the secondary coils of current transformers L1 and L2 and the capacitor C1 exceed the total rated voltage of the zener diodes VD3 and VD5. Thus a current will be introduced into the gates of thyristors VT1 and VT2.

Since the power of the input source is limited, the magnitudes of the currents are commensurable with the gate turn-on currents and the holding currents of the thyristors. Under such conditions, the resistances in the anode circuit influence the turning on of the thyristors. The resistance of this circuit, for thyristor VT2, is close to zero (i.e. the resistance of a discharged high capacitance capacitor), and for VT1 the nonlinear resistance of two series connected light-emitting diodes. For this

reason, thyristor VT2 is always the first to be turned on, and all the current conducted by this thyristor is consumed by capacitor C2 during charging. Capacitor C2 shunts the input signal source through its low resistance. When the capacitor is charged, and the current through it decreases down to the thyristor's (VT2) holding current, the thyristor turns off and disconnects the capacitor C2 from the input signal. At this point the appropriate conditions for turning on thyristor VT1 develop. Whenever thyristor VT1 turns on, the light-emitting diode VD4 provides a visual signal and if necessary a remote signal is provided by optocoupler VO1.

In view of the low power of the signal source and the absence of an external power supply, low-power high-sensitivity electronic components should be used in the device. The indicator prototype includes the following components: C106D1 thyristors, BZX85-C24 (VD2), BZX79-C18 (VD3) and BZX79-C3V0 (VD5) Zener diodes and a H11G1 optocoupler. Structurally, the device is shaped like a small plastic cylinder, (Fig. 3), with an axial aperture for the grounding bus flexible copper wire. On the lower face of the indicator there is a small aperture for the light-emitting diode and a miniature connector for an external circuit for a remote signal. In addition, there is a special label located opposite the reed switch which indicates where the permanent magnet should be placed in order to test the state of the indicator.

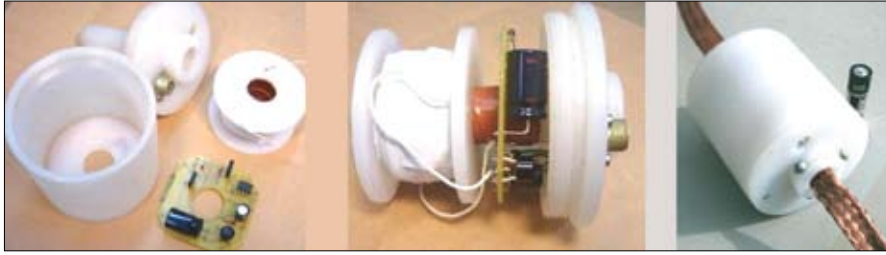
Fig. 3: Construction of the fault passage indicator.
